St John the Evangelist, Howsham – Safeguarding Precious Windows

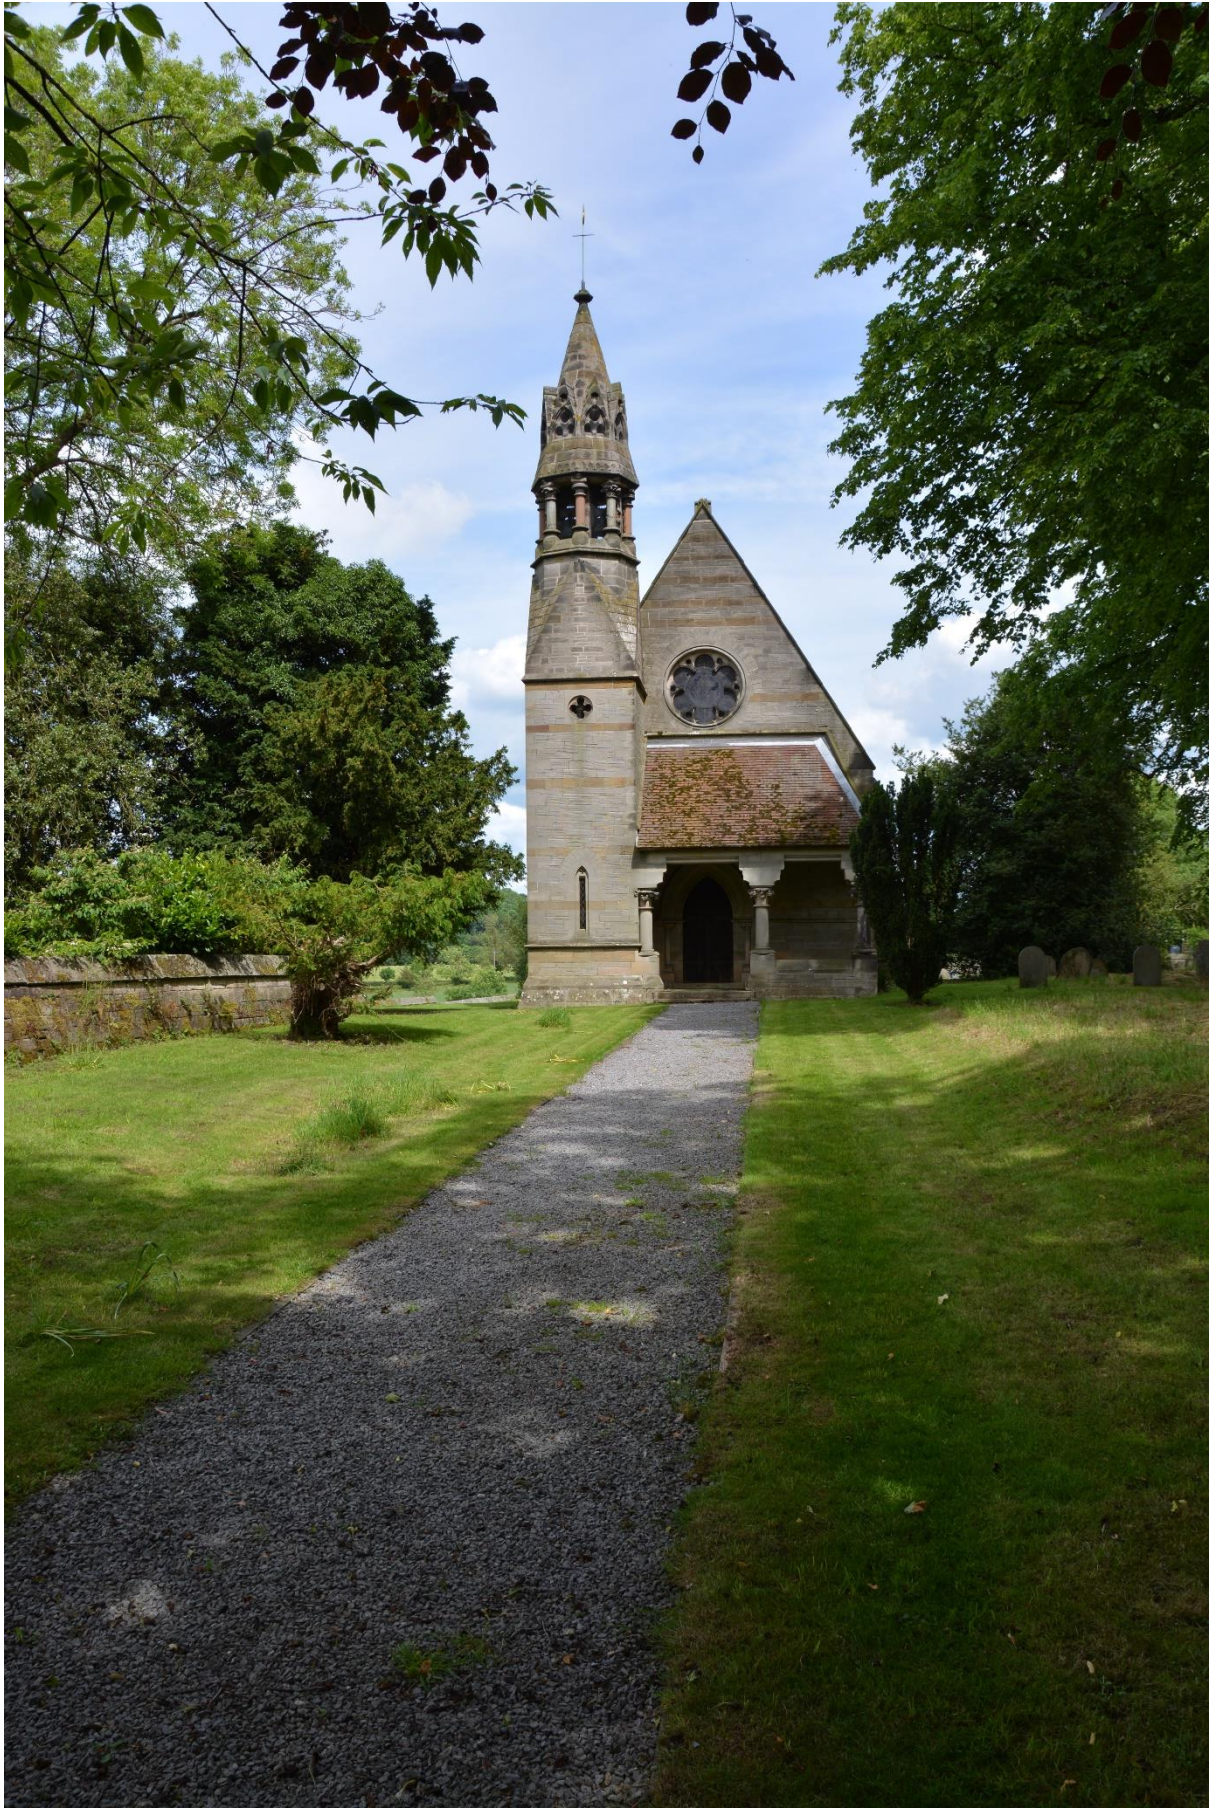
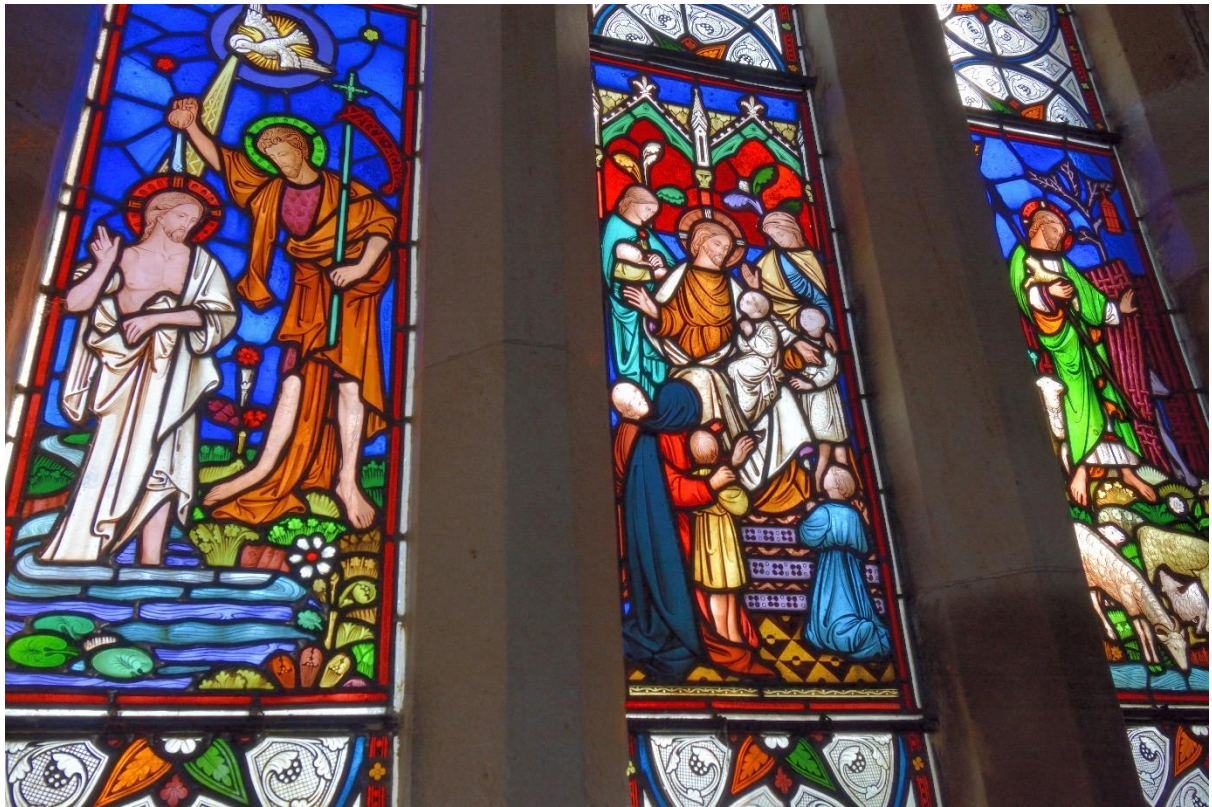
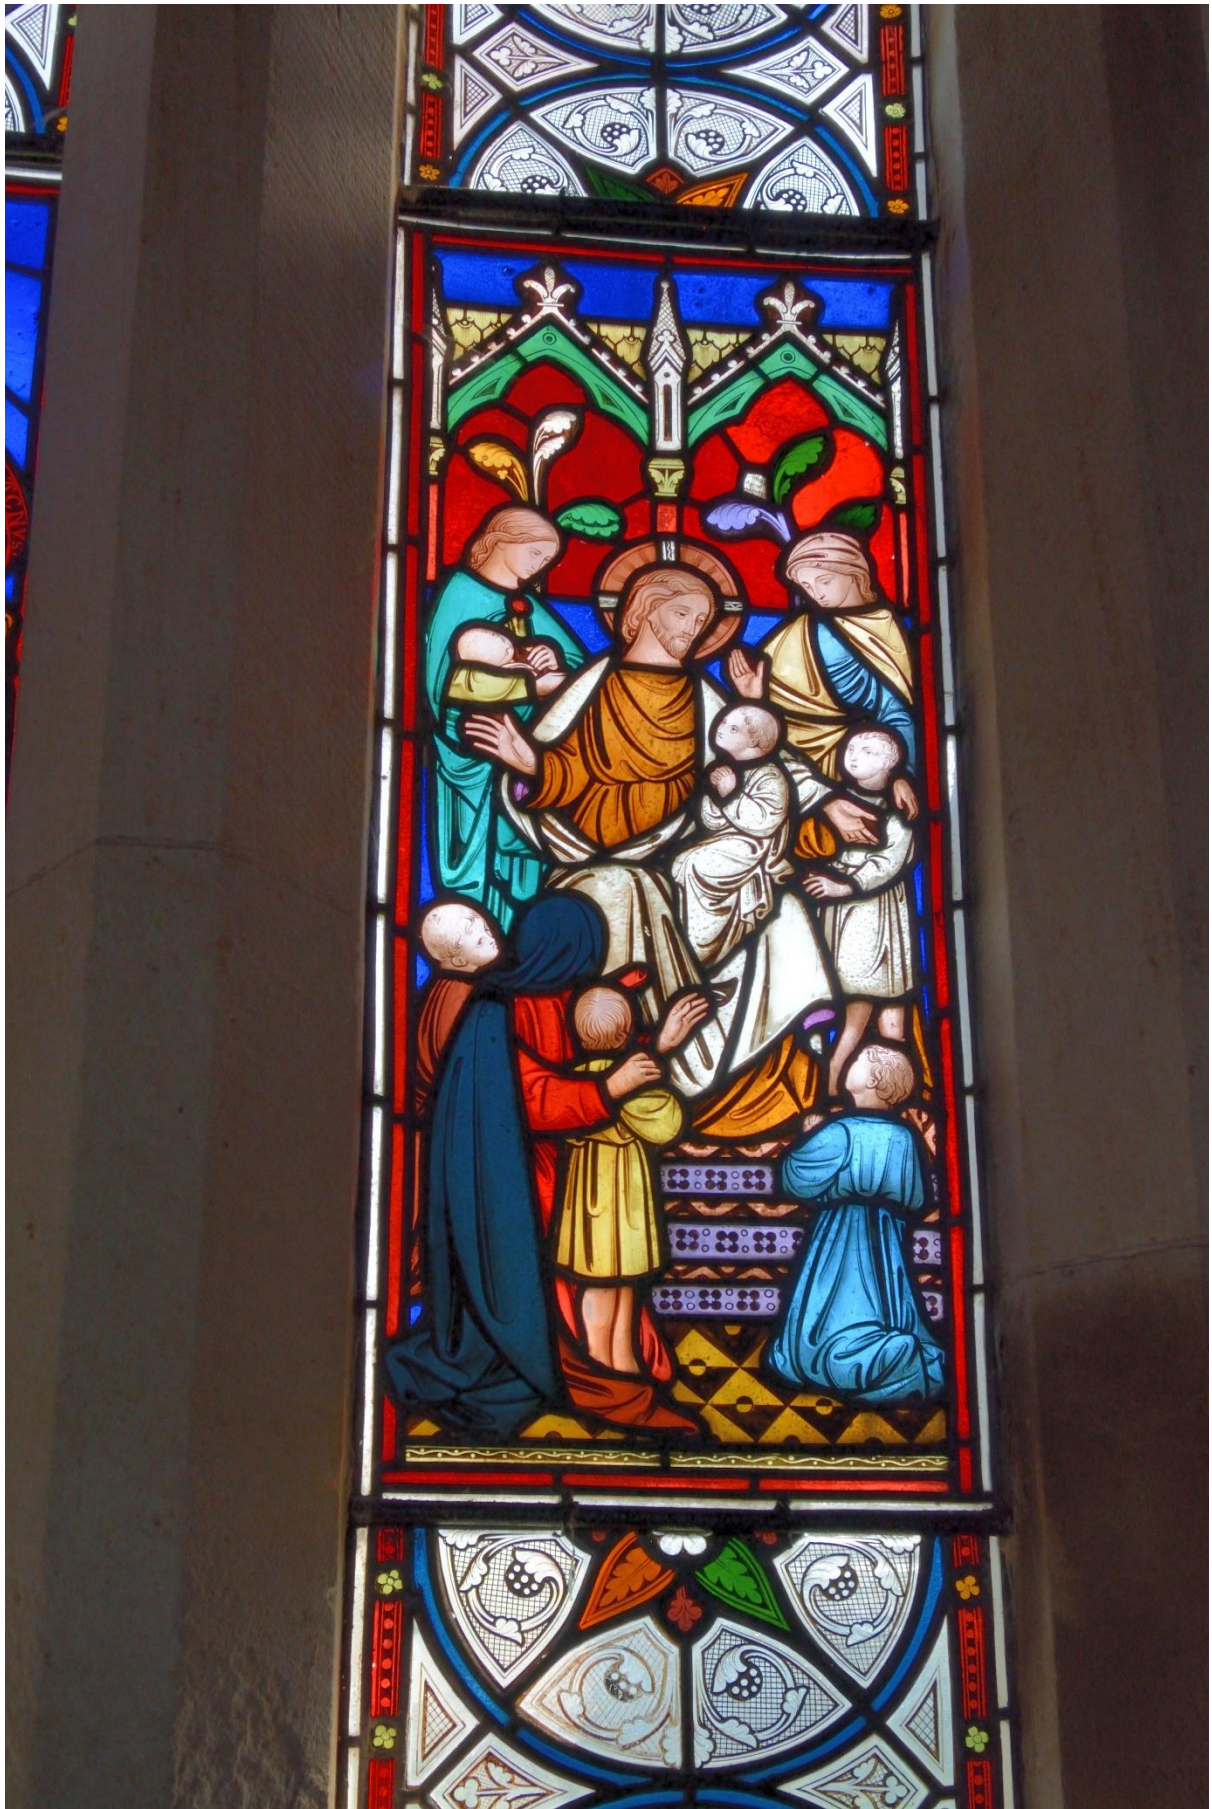
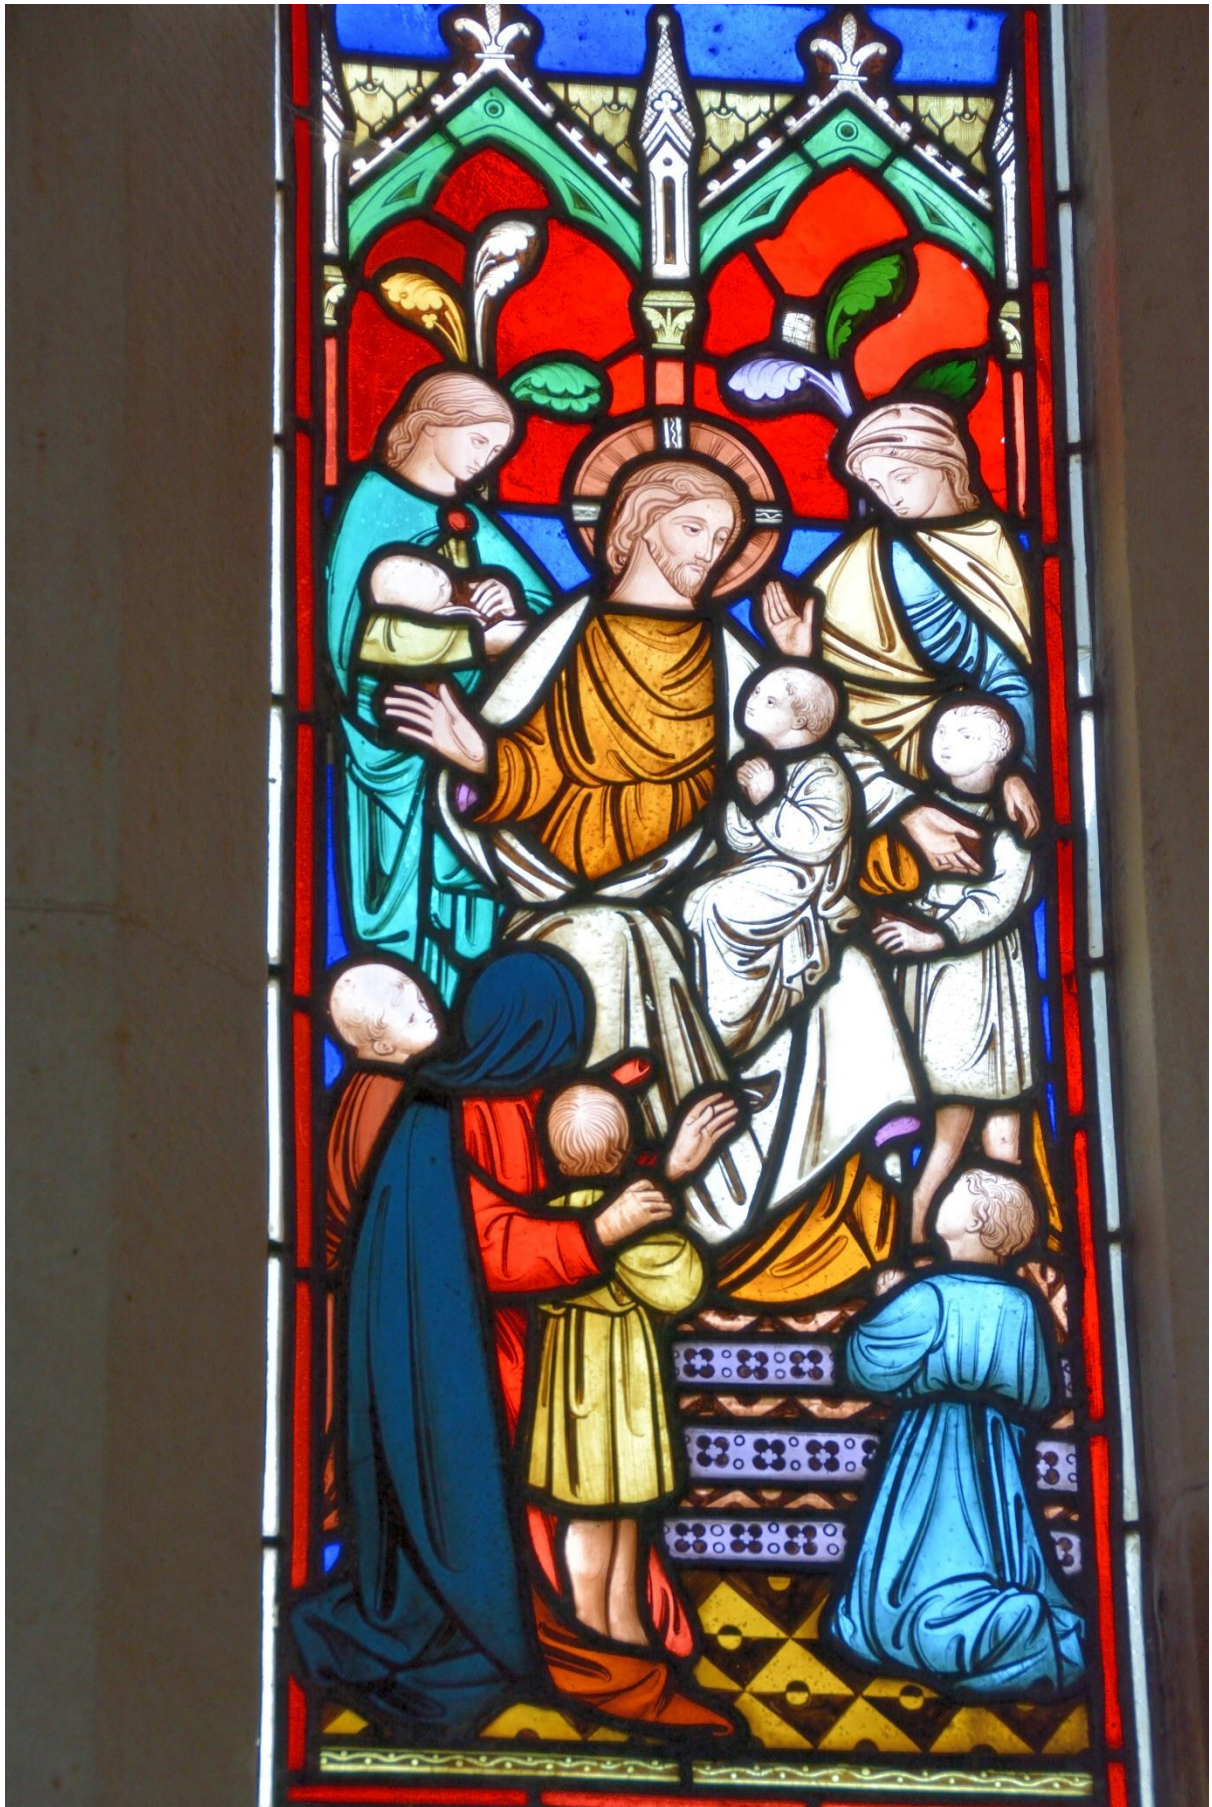
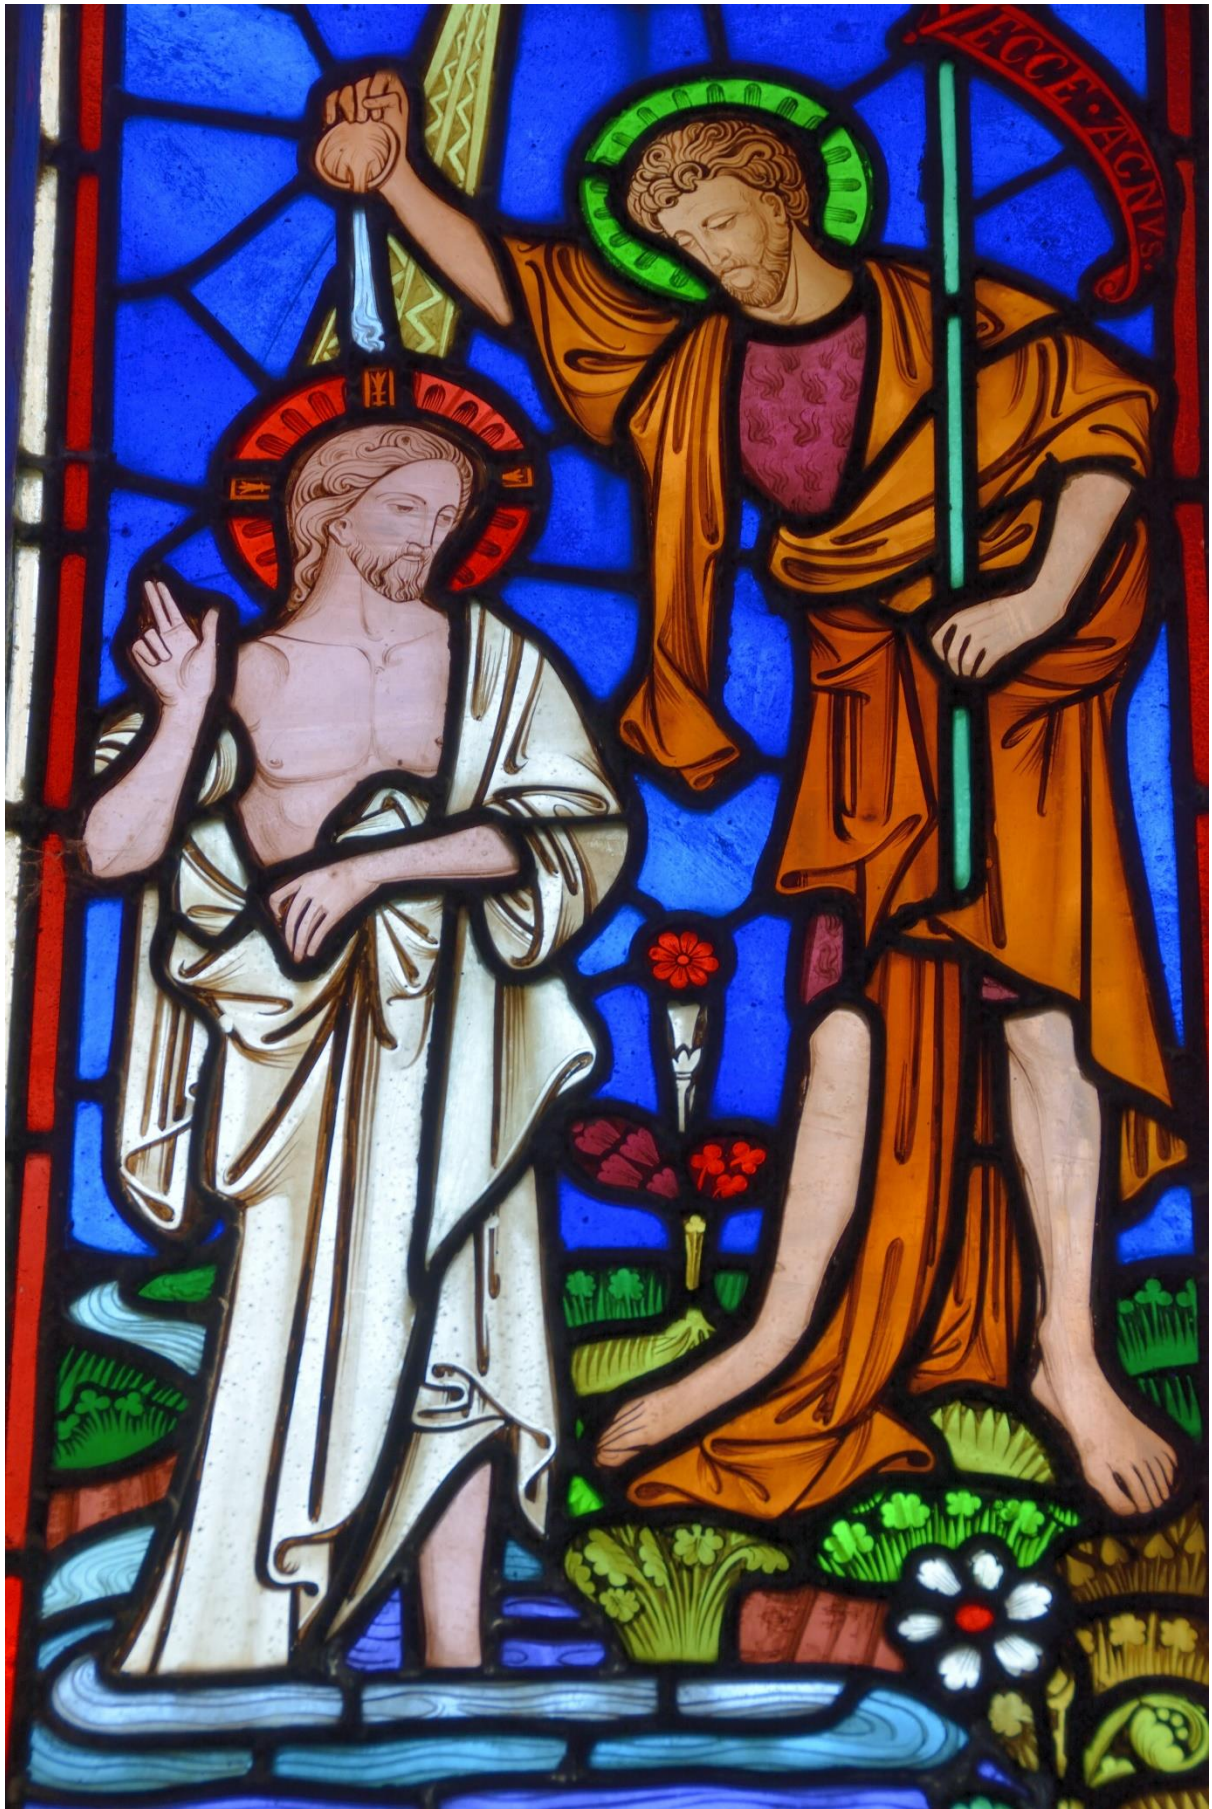
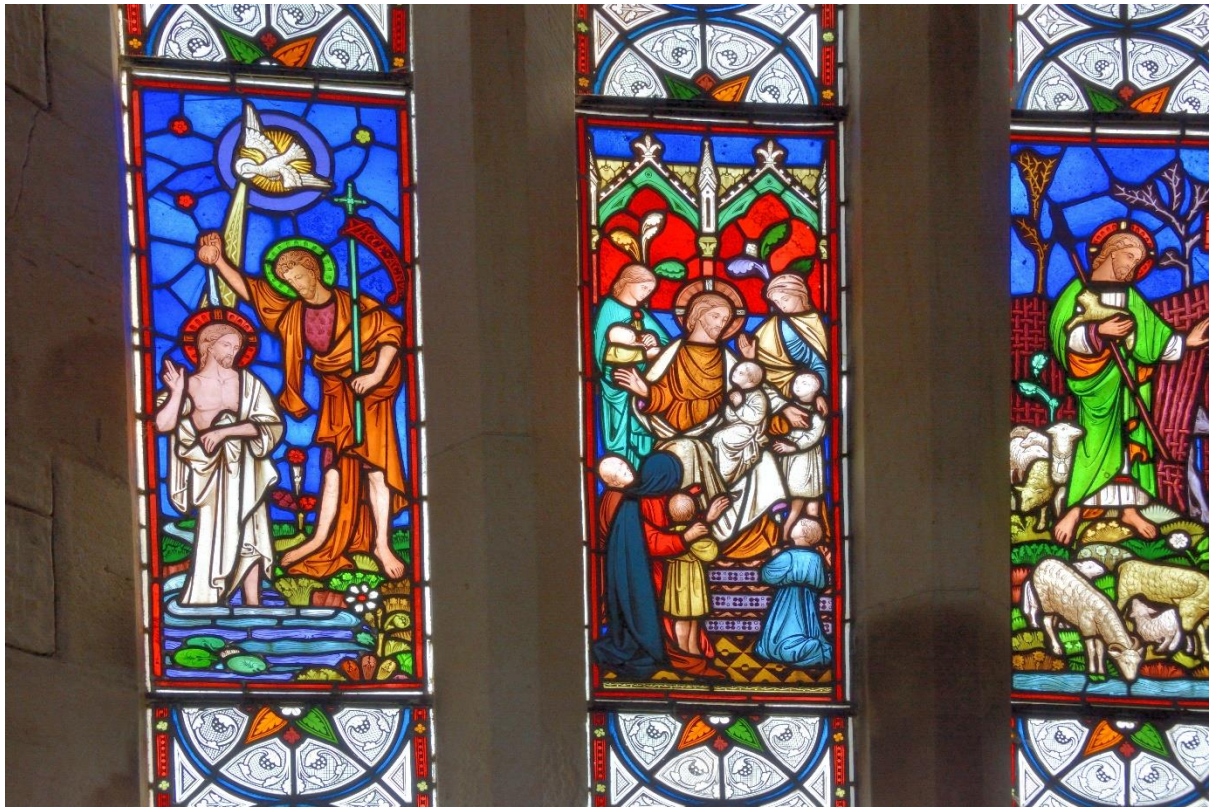
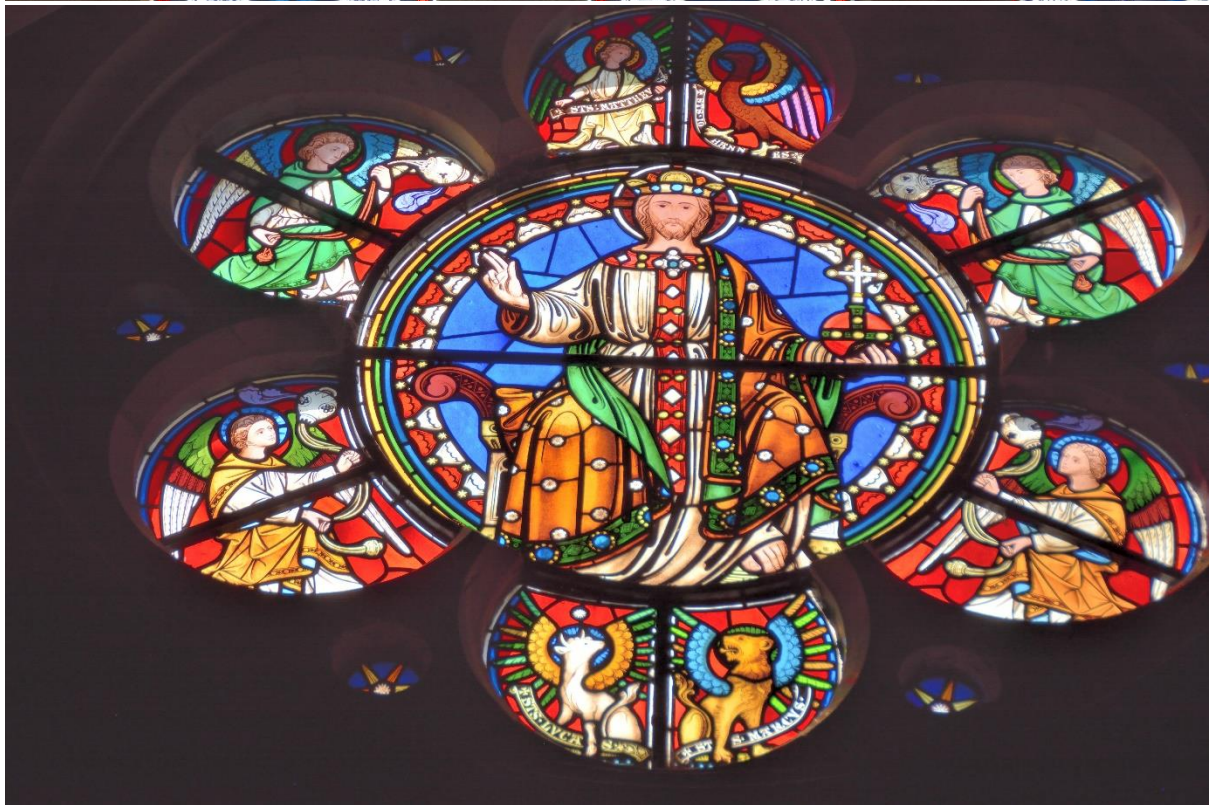
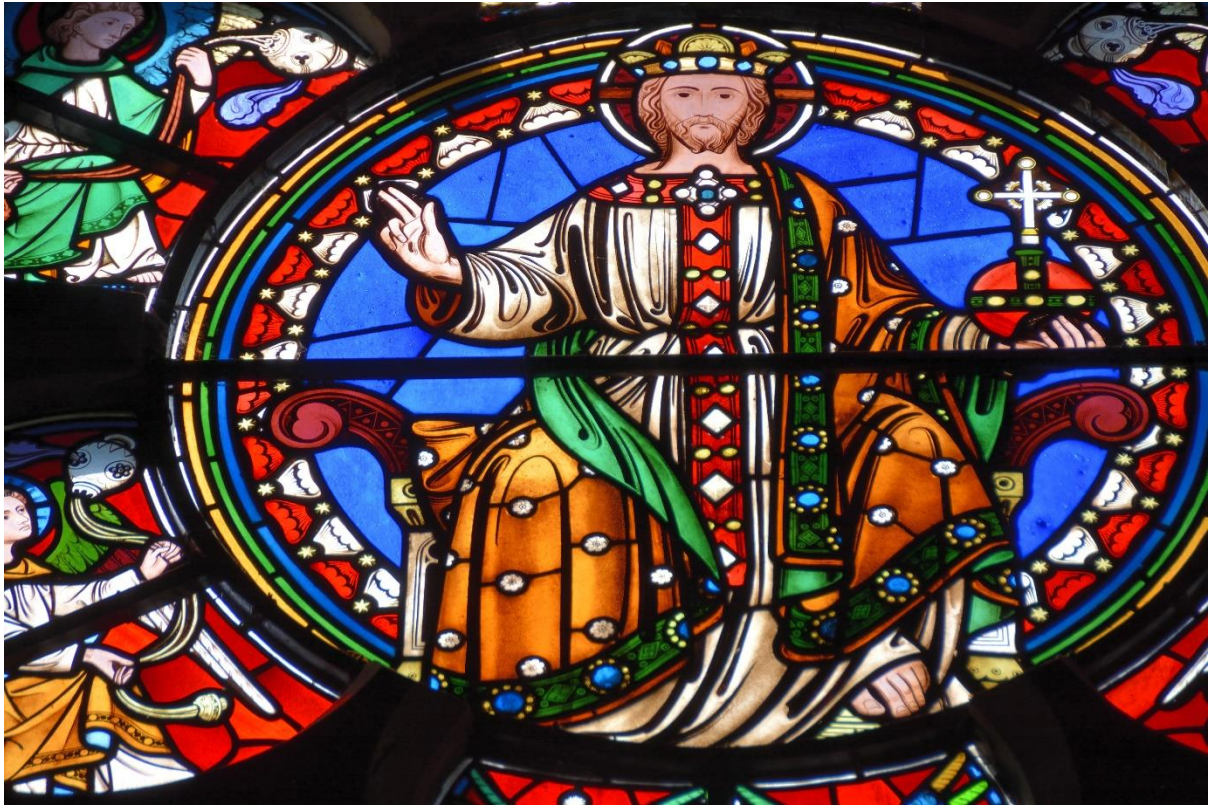
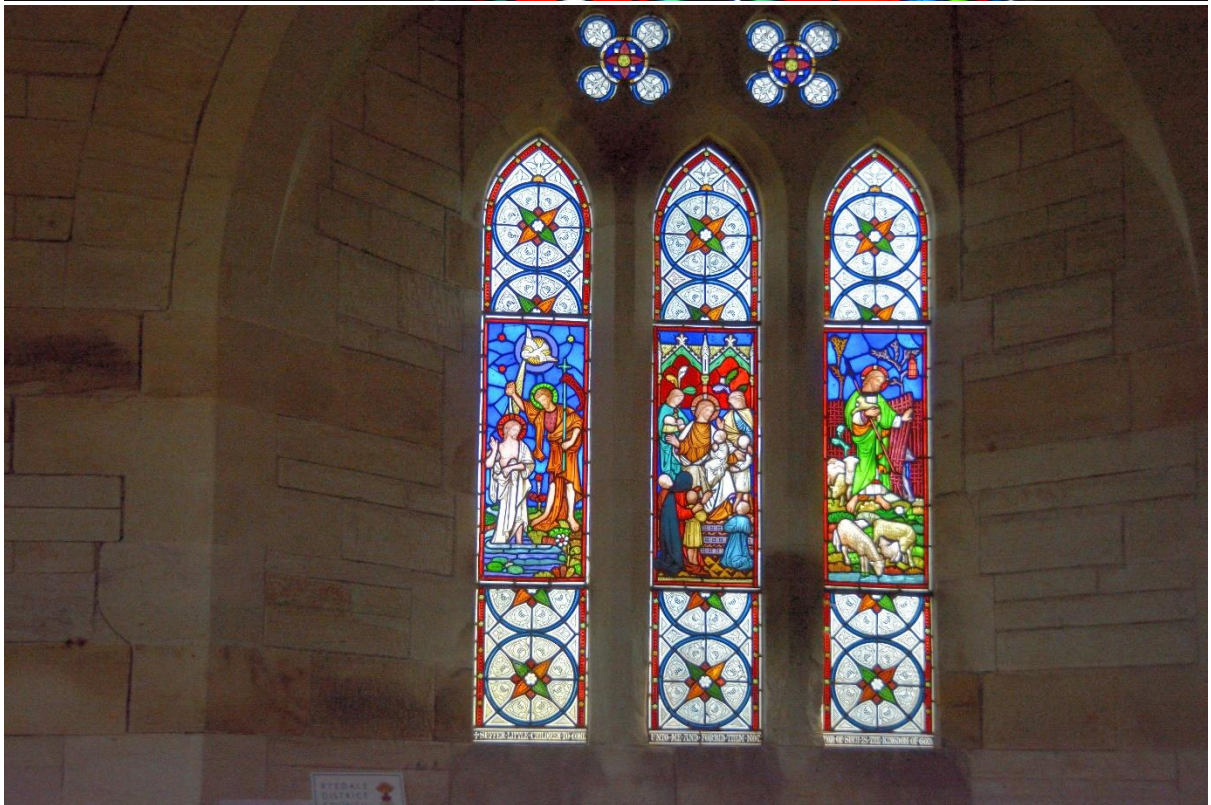
The pictures that follow show some of the windows that were treated.
