## **ST MARY'S CHURCH, SAND HUTTON RESTORATION PROJECT 2016 - 2018**

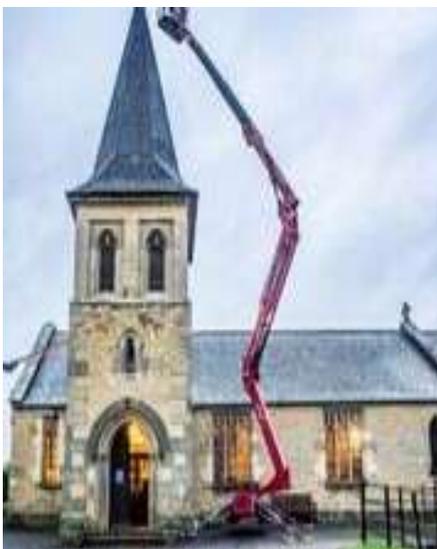
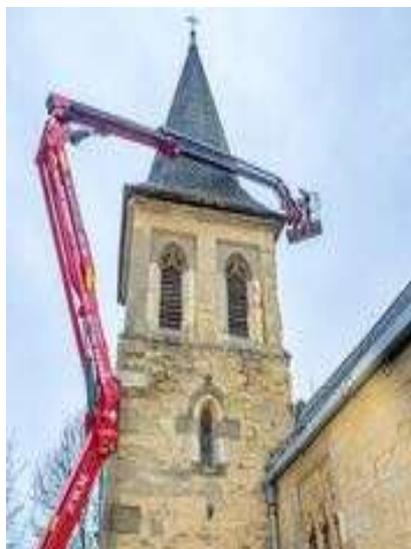
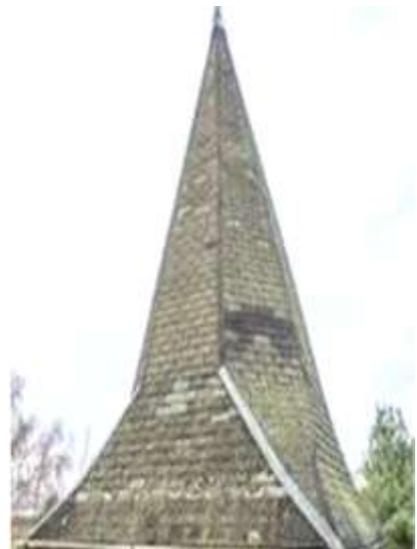
The spire had been damaged by woodpeckers trying to dislodge insects from under the shingles and felt covering which had left numerous large holes in the felt, some down to the broaches and others through to the timbers. Felt had worn through or was ripped and had totally deteriorated in places. Shingles were missing and others ripped. Water was getting into the building. In addition there were holes in the gutter with water leaking onto the tower back gutter and the fall pipe was cracked.

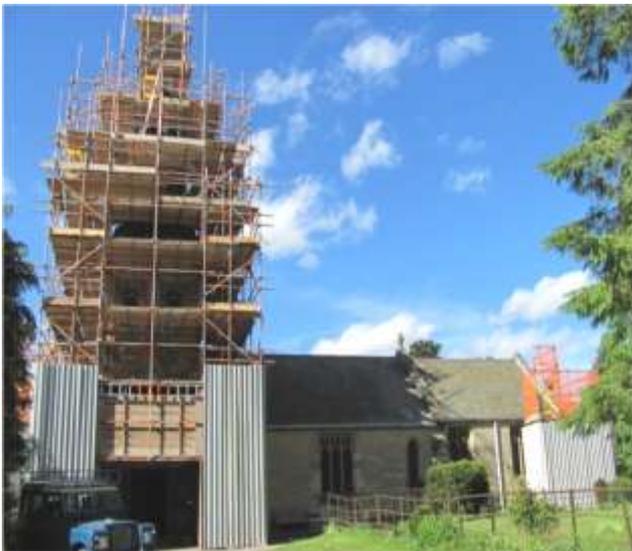
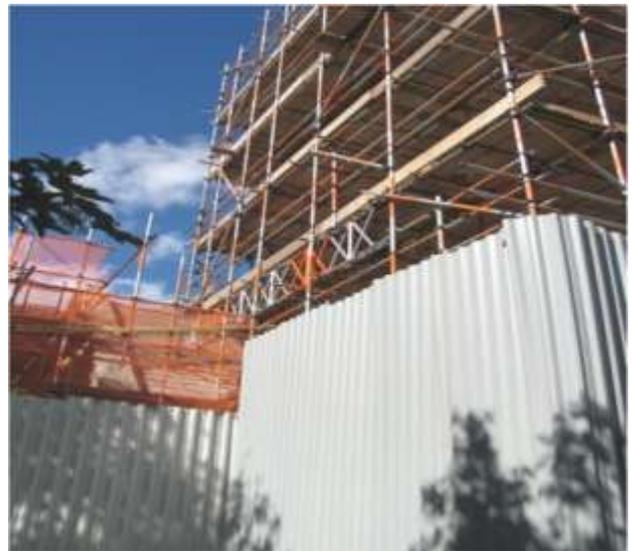
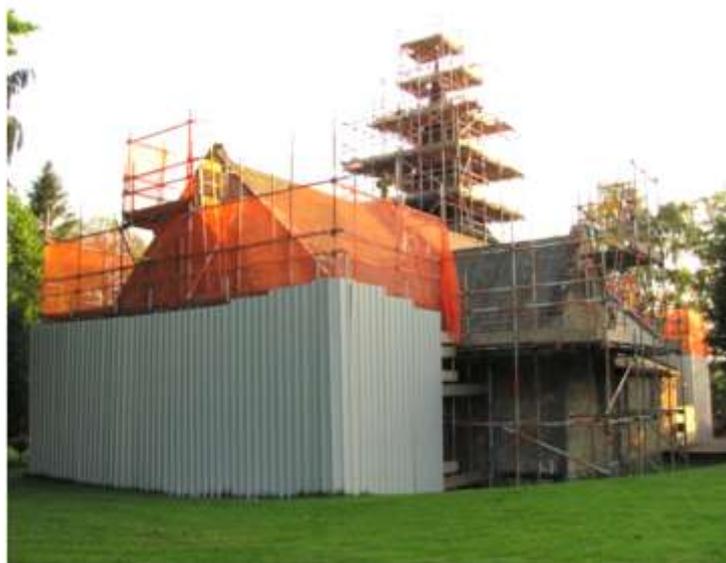
Scaffolding, metal sheeting and heras fencing were erected around the west end, tower, east end, chancel and vestry in May and a second bat survey was undertaken. The site office and store appeared and the external appearance of St Mary's began to change significantly.

Masonry work started, removing damaged ashlar and quoins, working new ones and replacing them – this work was ongoing throughout the project.

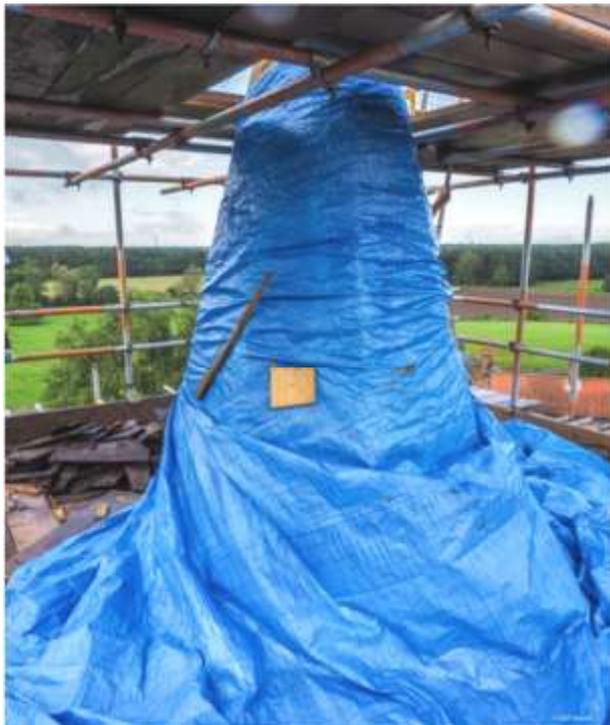
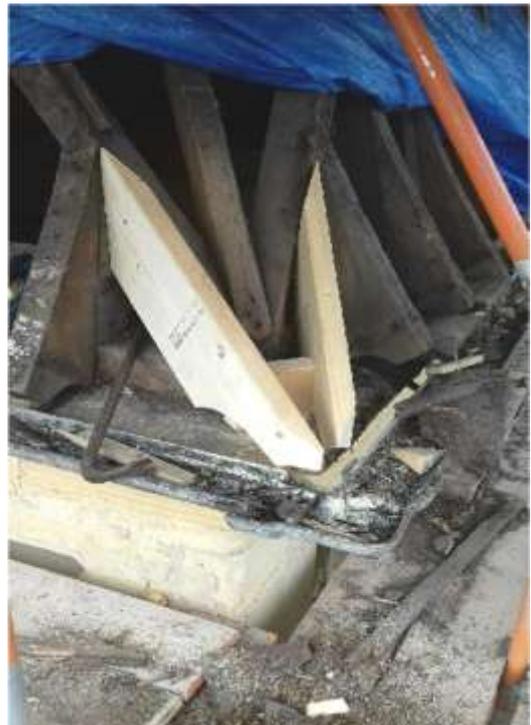
May 2017 witnessed the spire being stripped of all its shingles and wrapped in a protective blue cover. This enabled work to be undertaken in June on the wooden structure of the spire.

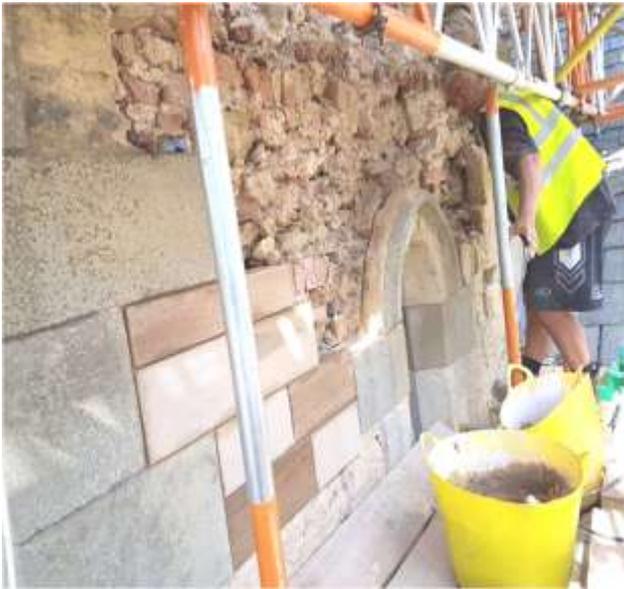
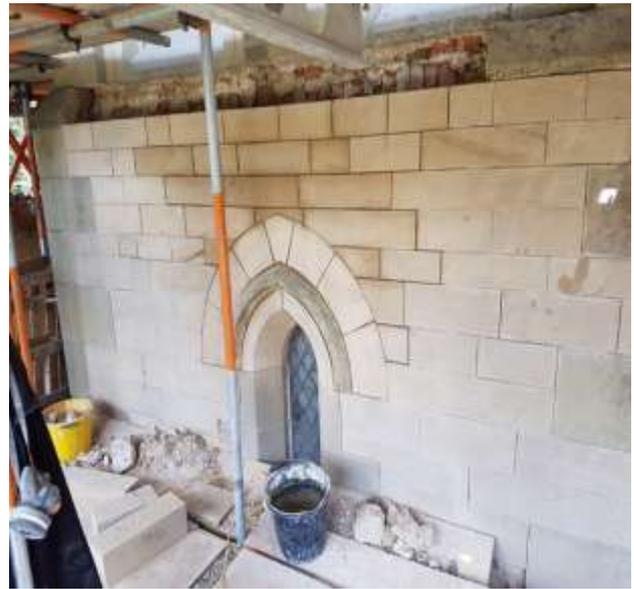
September witnessed all of the ashlar stones, voussoirs and jamb stones to the small windows worked and fixed to all elevations of the tower. Eroded stonework was replaced down to cill level on the east and west elevations.

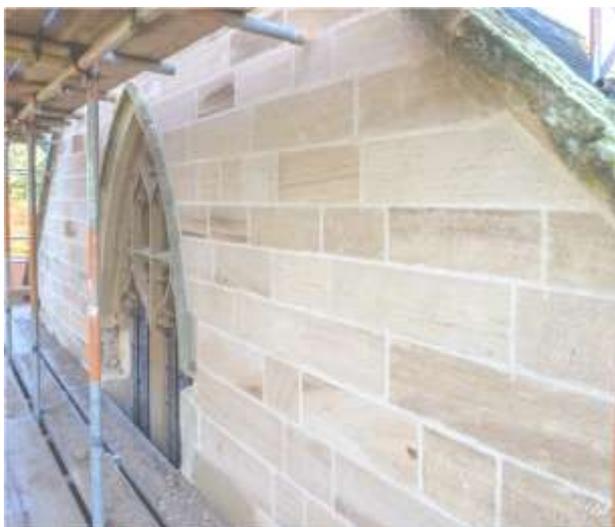
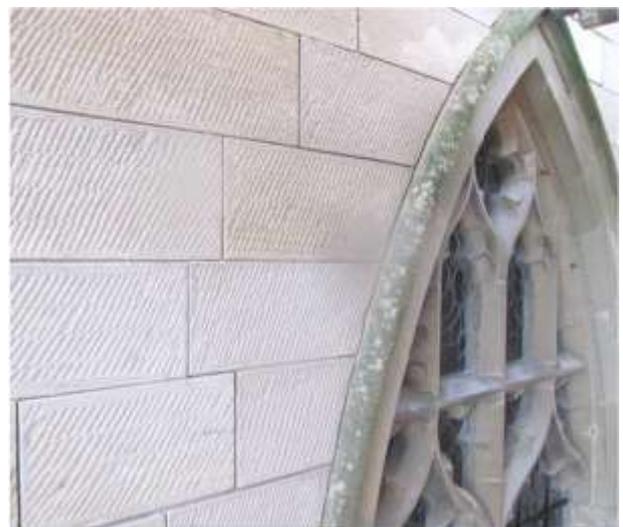
All ashlar replacements were completed to the nave west gable, vestry and chancel. 42 extra ashlars were replaced to complete the replacements to the edge of the window hoodmoulds.

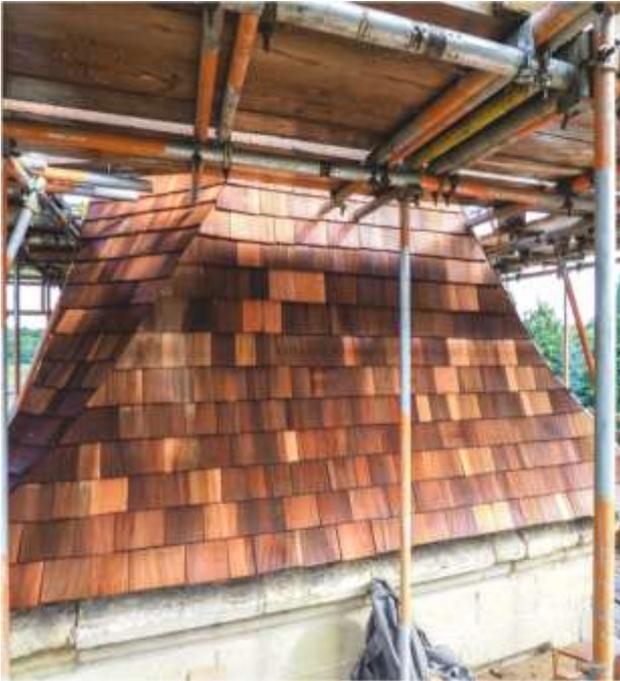
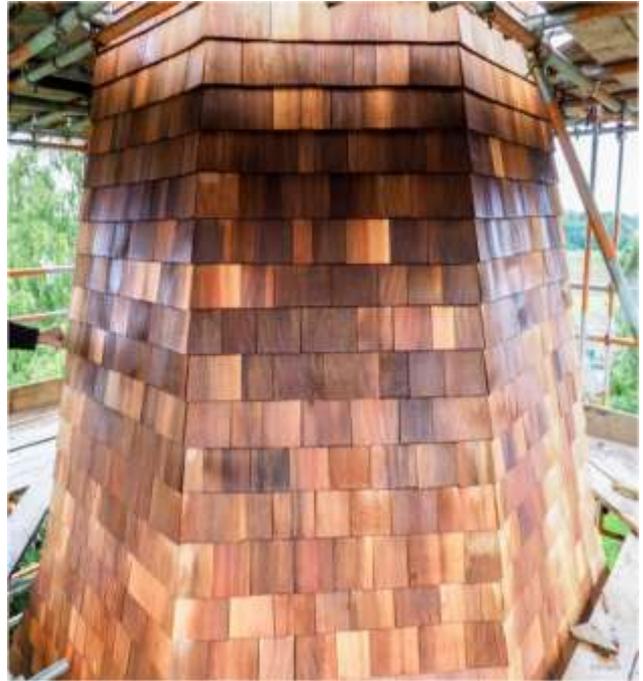
The spire had repairs carried out to the hip areas and to the finial. 100% of the sarking boards were replaced and the majority of the re-shingling of the spire was completed.

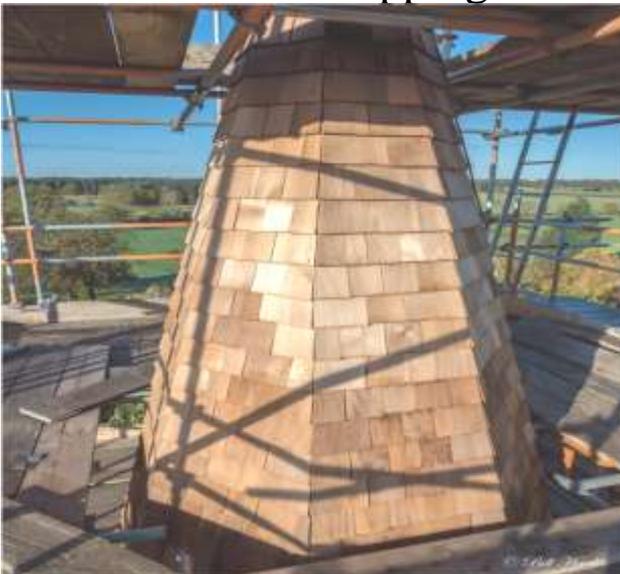
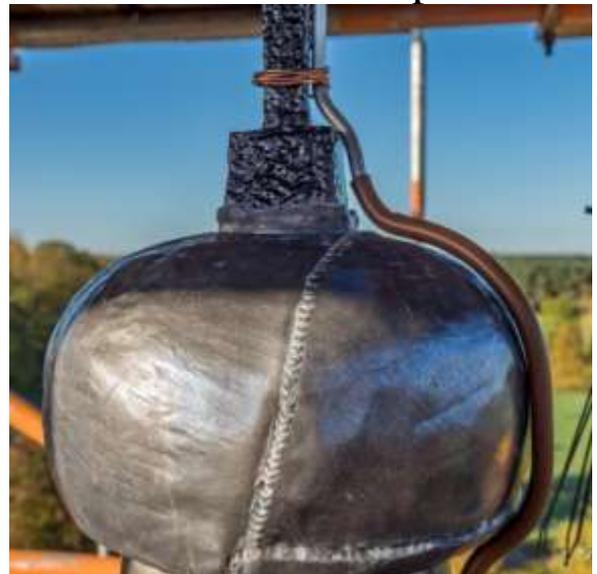
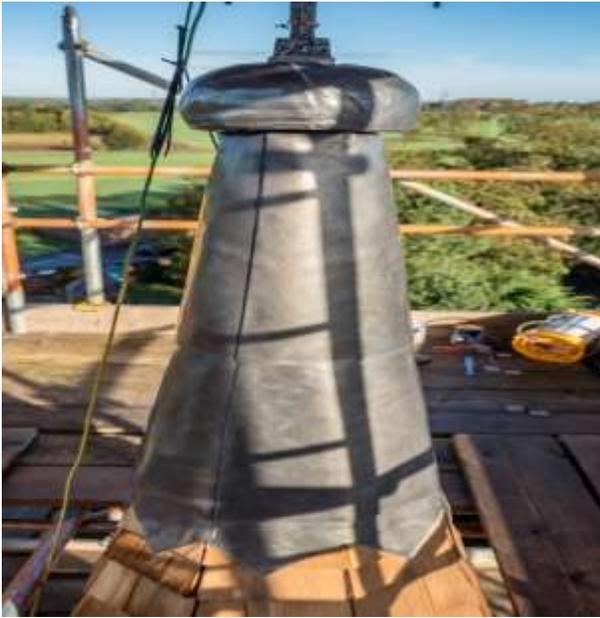
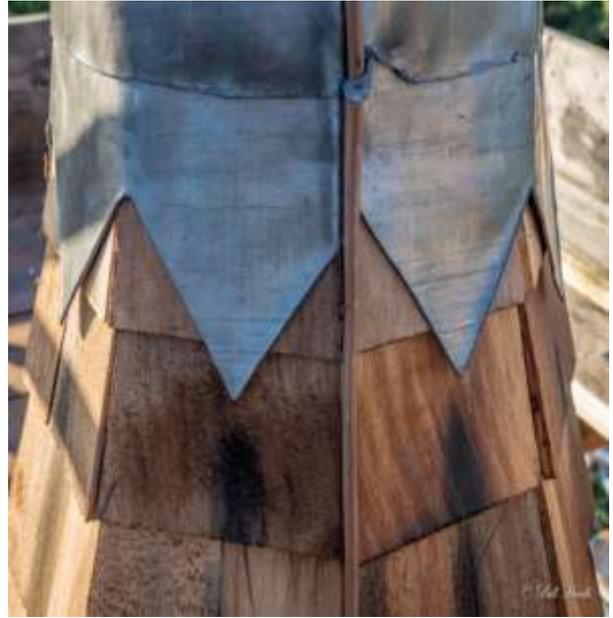
In late October the shingle work was completed and a repaired and re-leaded button capping was created at the head of the spire.

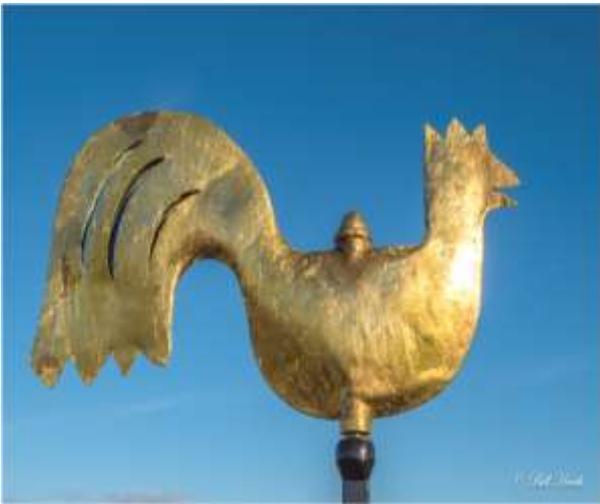
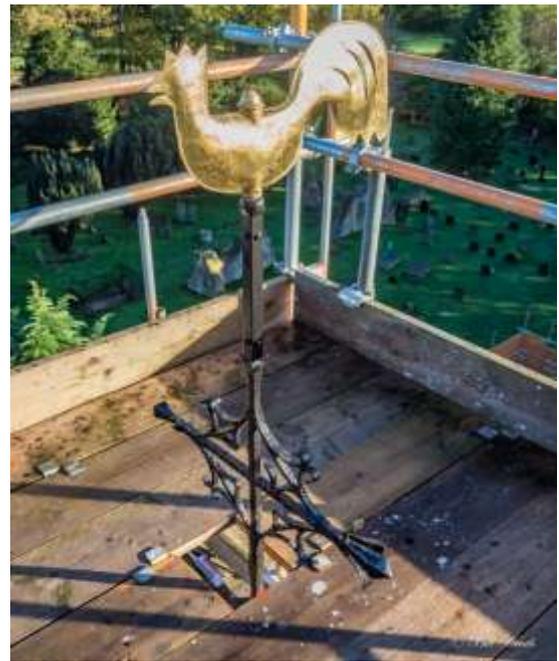
The wrought iron cross at the top of the spire was painted and the newly re-gilded cockerel, returned to its 1885 specification, was re-instated surmounting the cross.

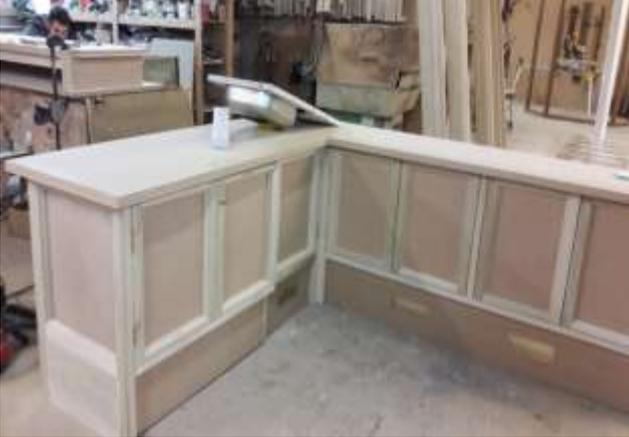
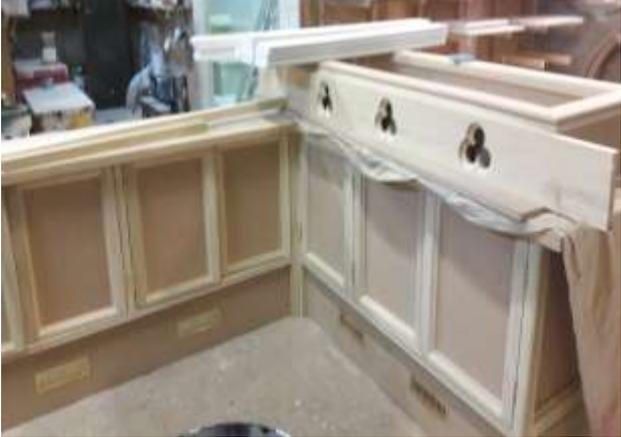
Preparations in the workshop:

During November and December the work inside St Mary's began. Our new kitchen and heritage area units were built and placed in situ at the west end of the church – these were designed to complement the aesthetics of the church.

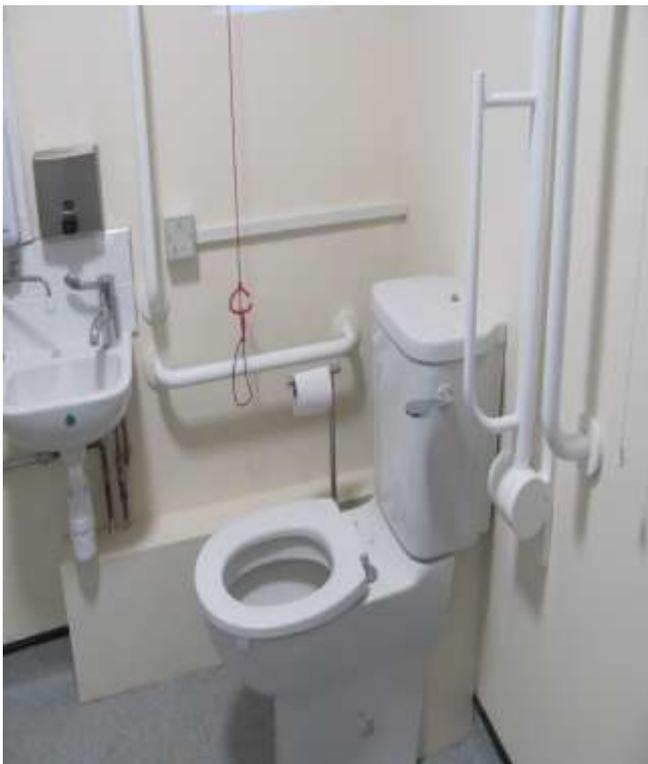
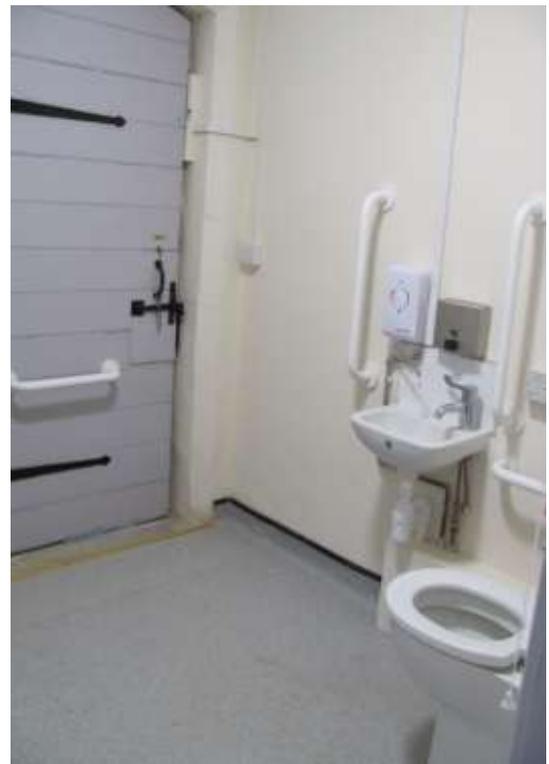
The old vestry was divided into two distinct areas: a toilet and store. Fittings were installed, new flooring laid and first fix electrics undertaken.

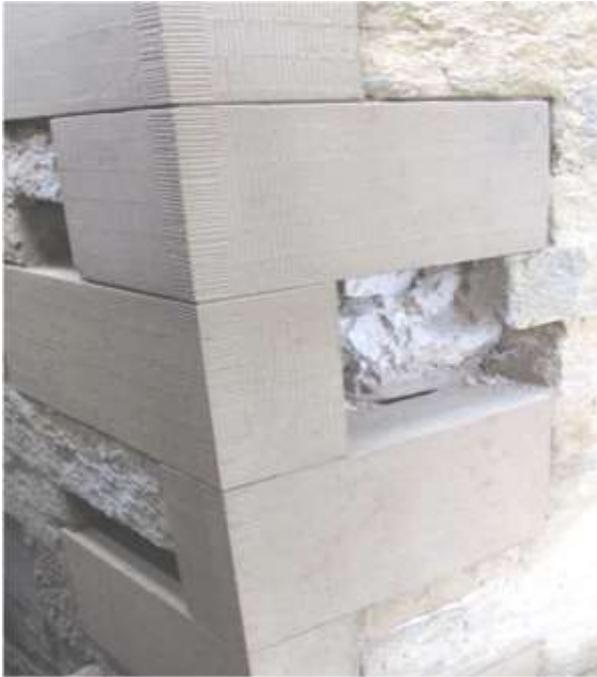
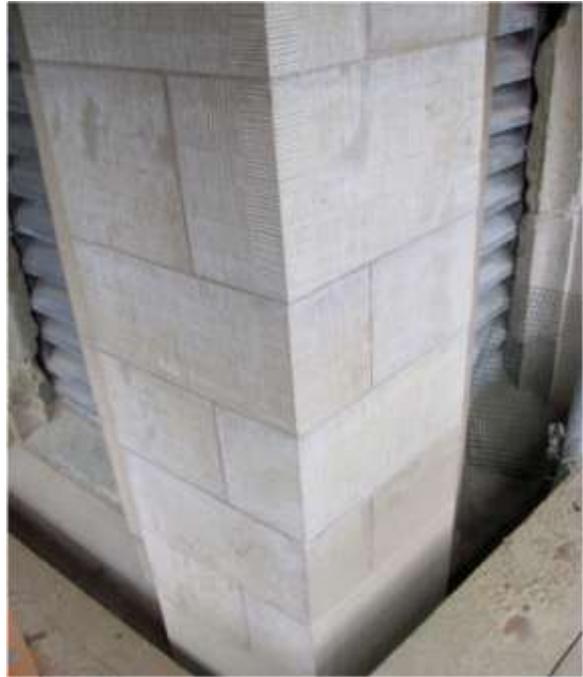
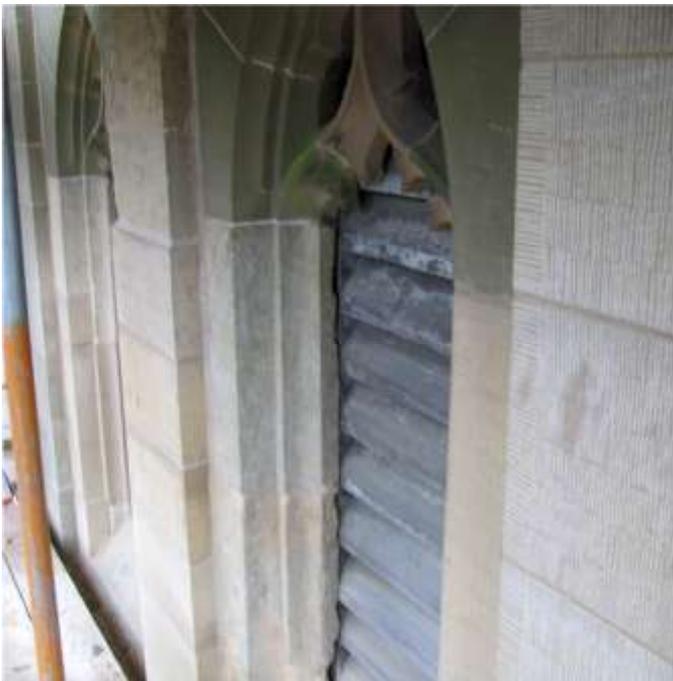
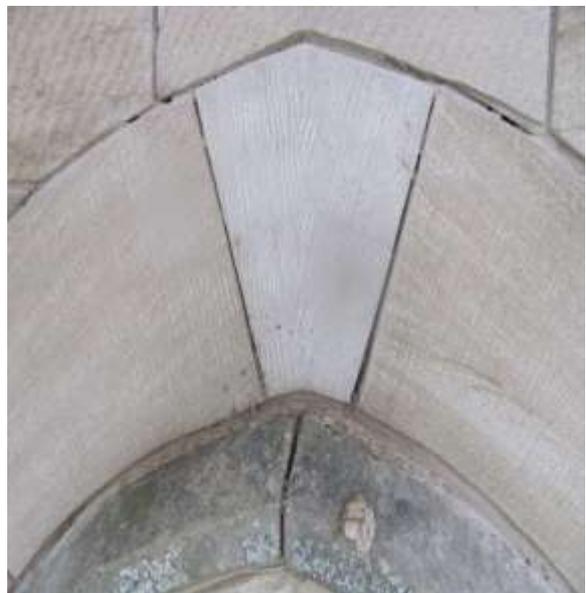
Work on the stones (quoins, jambs, voussoirs) for the tower continued throughout January and February – tooling and fixing; also the remaining masonry work to other areas and lower walls.

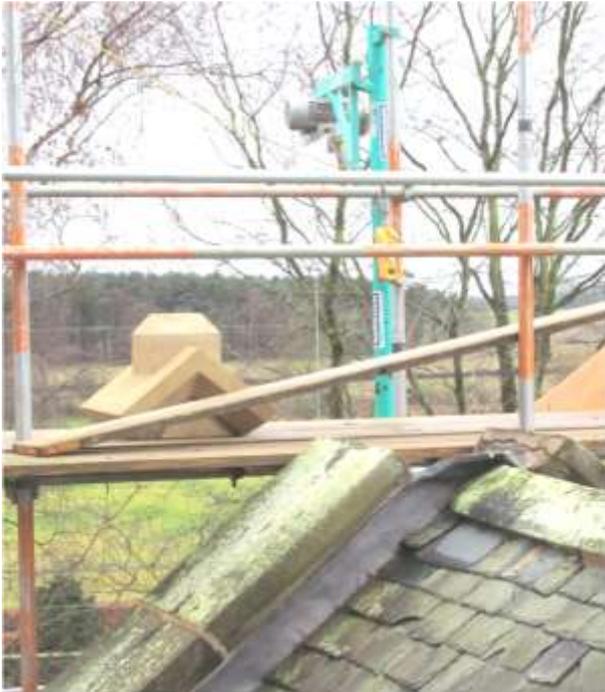
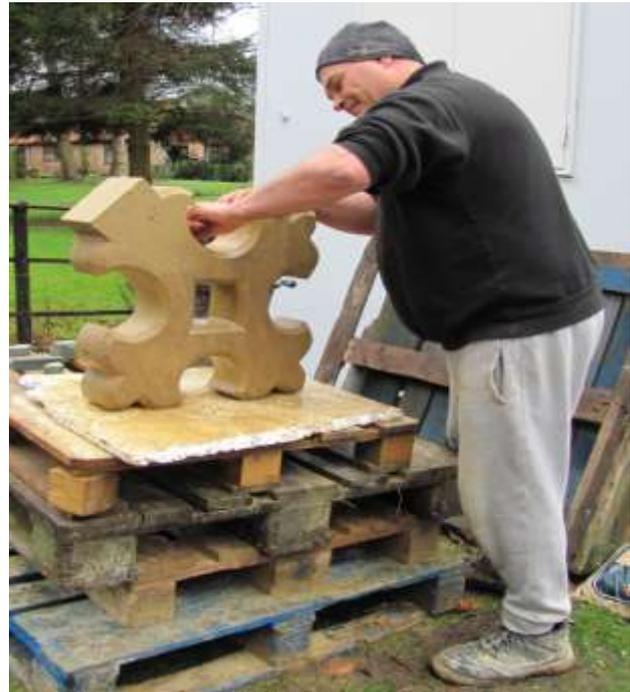
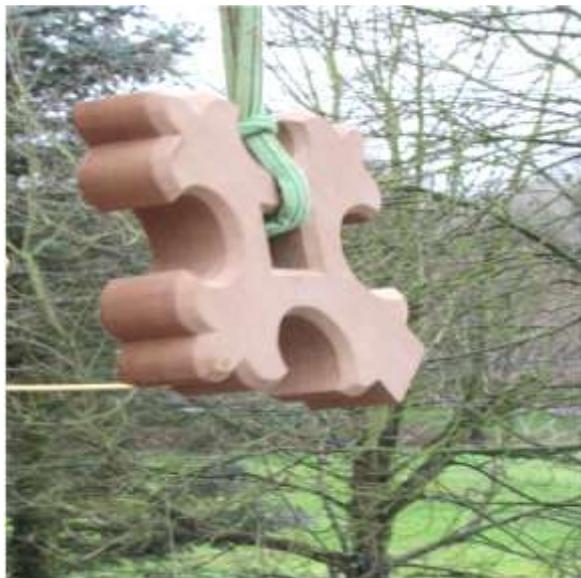
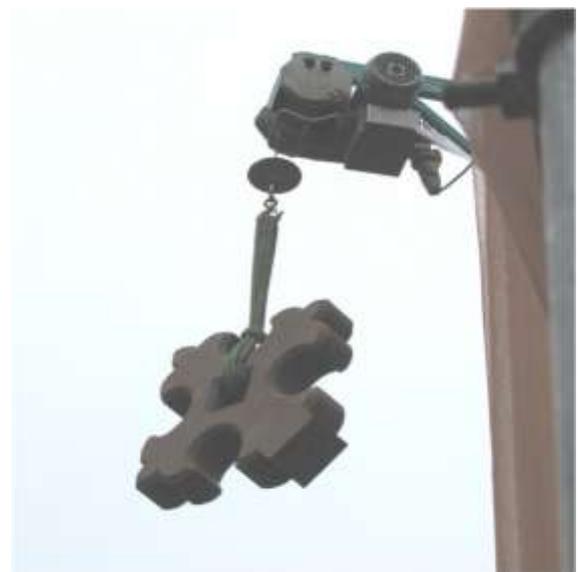
February was a rather hectic month as the project began to draw to a close. The guttering was fitted around the base of the spire, the belfry louvres were re-instated with new mesh on the interior, glazing work was completed on the windows in the tower.

The new base and cross for the west end was carved, hoisted aloft and positioned.

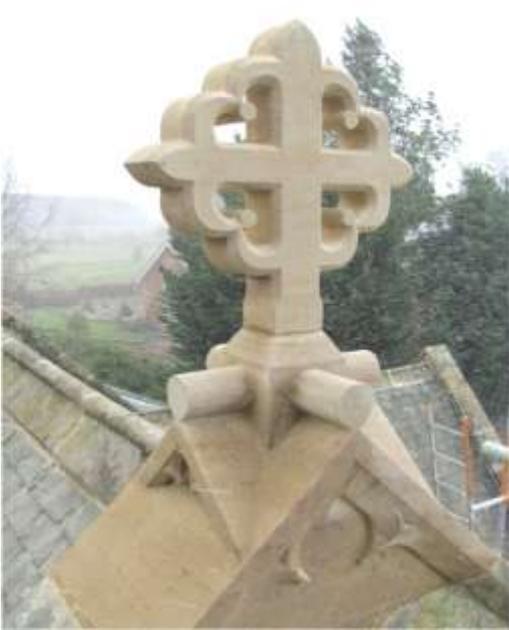
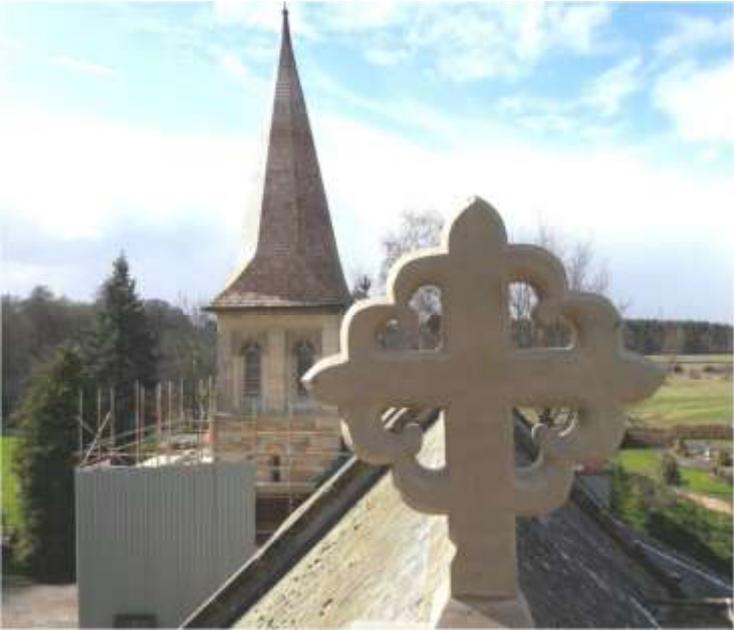
Andy, our stonemason, worked long hours carving the intricate apex stone and cross for the east end and they were placed in situ, completing the restoration of St Mary's three crosses.
